**RESULTS OF INVESTIGATIONS OF
FAILURES OF GEOTHERMAL
DIRECT-USE WELL PUMPS**

**U.S. Department of Energy
Contract No.: DE-FG07-90ID 13049 A007**

Gene Culver

**Geo-Heat Center
Oregon Institute of Technology
Klamath Falls, OR**

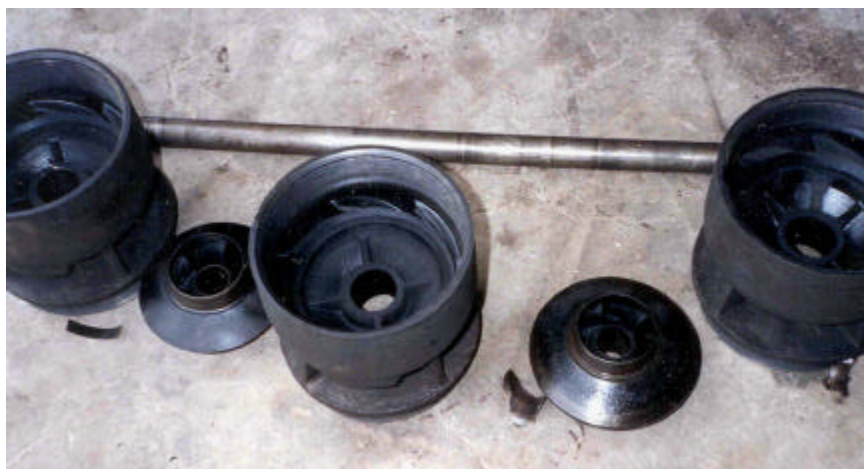
The lower bearing in the oil tube was badly worn--hourglass shaped. There were only bits and pieces of bowl bearings except for the tail bearing which was worn but still intact. Starting at the top, the first impeller skirt was worn completely away; 2nd, 3rd and 4th impeller skirts were worn but still attached; 5th and 6th skirts were completely gone; 7th worn but attached; 8th completely gone; and 9th, 10th and 11th skirts were there. The 11th or bottom impeller and bowl showed the least wear. Lateral had been correct as evidenced by no wear on top of impellers and machining marks visible on bottoms. An identification number was readable on the bottom impeller.

Figure 9. Top bowl, 2nd impeller, 2nd bowl, 3rd impeller, 3rd bowl, and missing bearing remains.
