**DIRECT USE GEOTHERMAL APPLICATIONS
FOR BRAZED PLATE HEAT EXCHANGERS**

Kevin Rafferty, P.E.

Geo-Heat Center
Oregon Institute of Technology
3201 Campus Drive
Klamath Falls, OR 97601

TO: Oregon Institute of Technology
SUBJECT: BRAZED PLATE HEAT EXCHANGERS
REF. NO.: 5703032

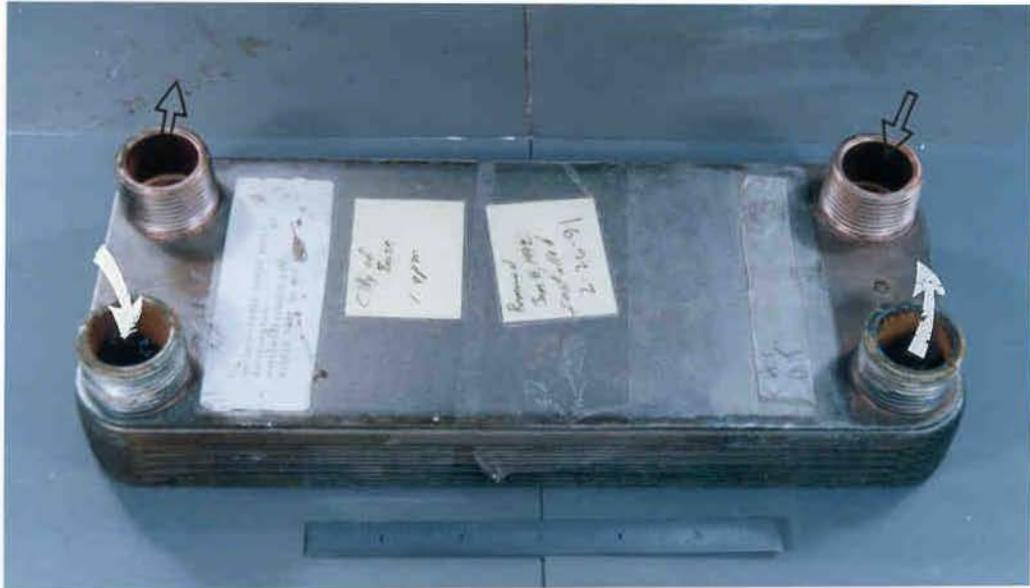
FIG. 2
(12102)

Type	B15*010
Serial Number	19010-13010-2564
Size	18½ X 3 X 1 inches
Service Location	OIT

It was installed January 7, 1991 and removed January 27, 1992. Total service time was 55 weeks. The inlet and outlet ports for the geothermal water and domestic water are shown by white and black arrows, respectively.

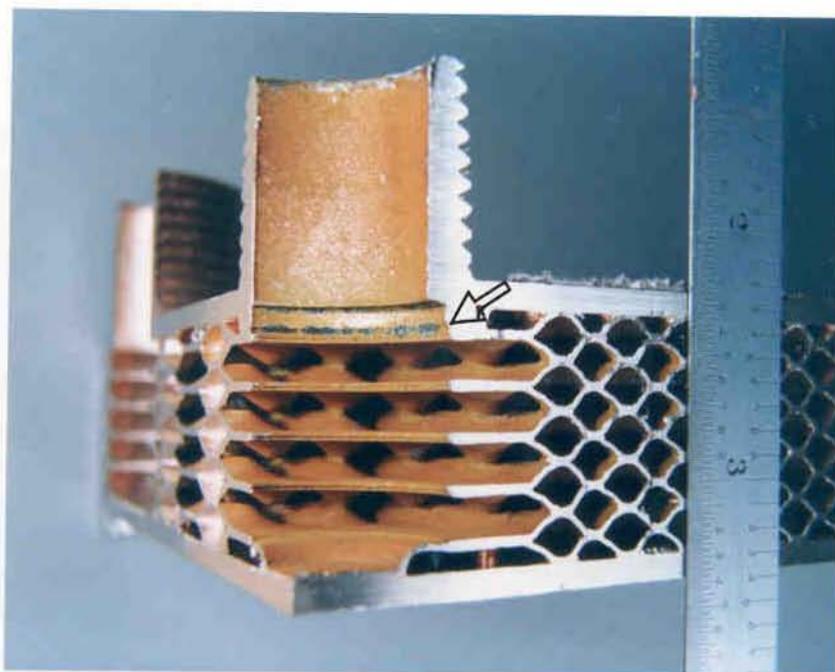
FIG. 4
(12104)

The deposits were primarily a mixture of corrosion products and geothermal minerals and consisted of iron, copper, zinc and silicon compounds with lesser amounts of sodium, aluminum, sulfur, calcium and manganese. These deposits were probably derived from dissolved solids in the geothermal fluid and corrosion products from other components of the system.

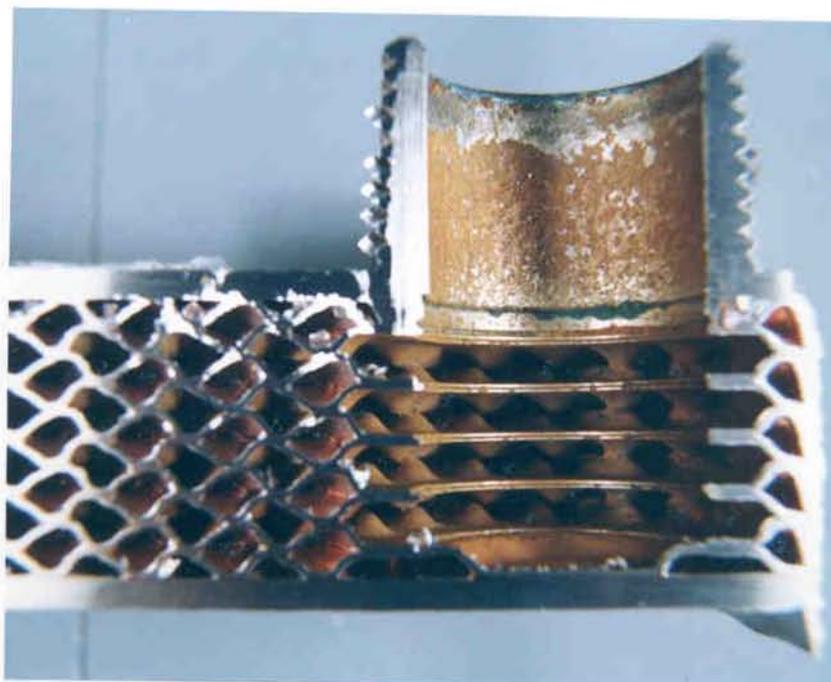
FIG. 5
(12105)

This photograph shows the internal surfaces of the hot geothermal fluid outlet port of the heat exchanger from the City of Boise system. These surfaces had conditions similar to the inlet port with a somewhat thicker film of deposits.

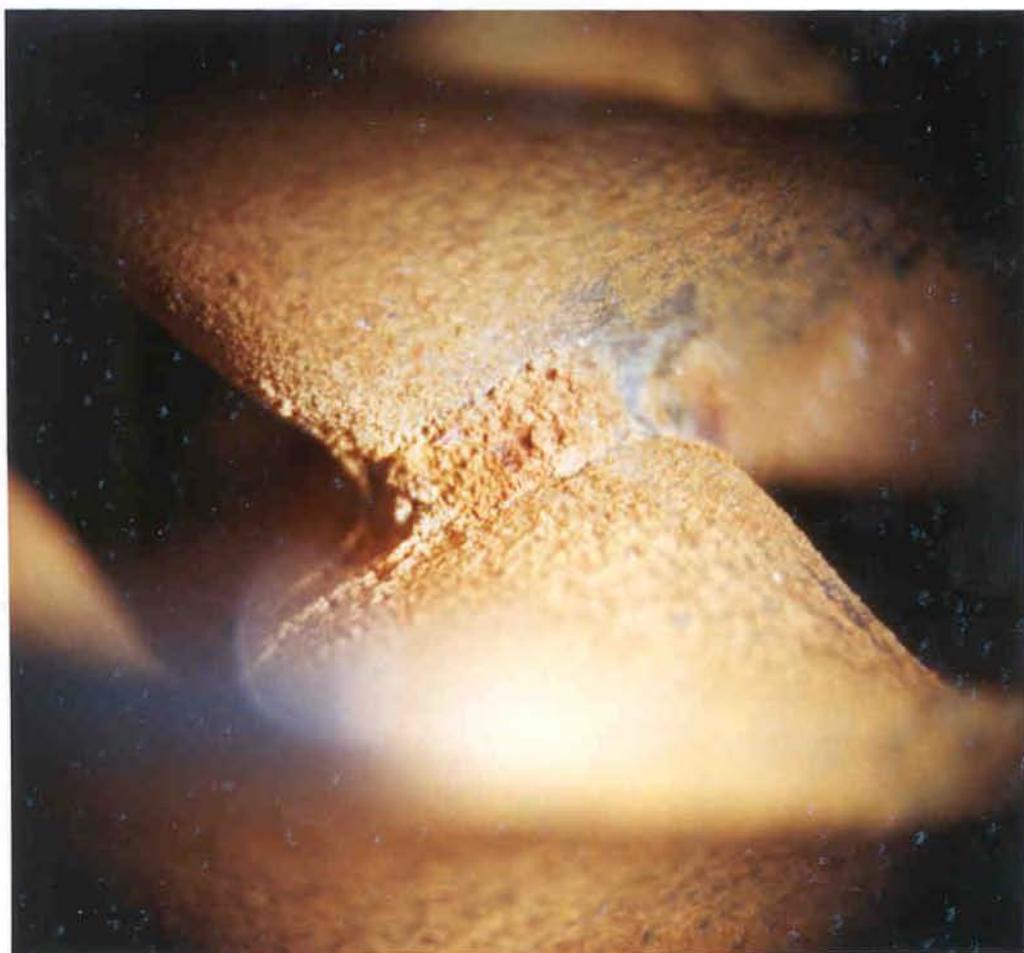
FIG. 6 (12106)

This photograph is a magnified view of a brazed plate joint in the outlet port area. The deposits on the joint were a mixture of corrosion products from the joint braze metal and mineral deposits. The corrosion products were primarily copper oxides with minor amounts of iron and chromium.

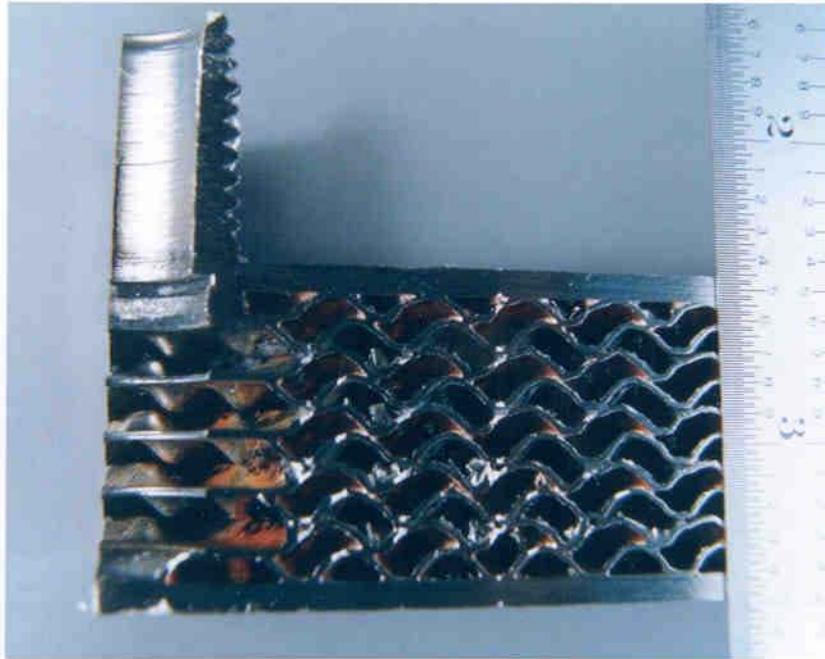
FIG. 7
(12107)

This photograph shows the internal surfaces of the hot geothermal fluid inlet port of the heat exchanger from the OIT system. The surfaces were coated with an irregular black film of corrosion products. The corrosion products were copper and sulfur compounds with moderate amounts of iron, chromium, nickel, silicon and tin.

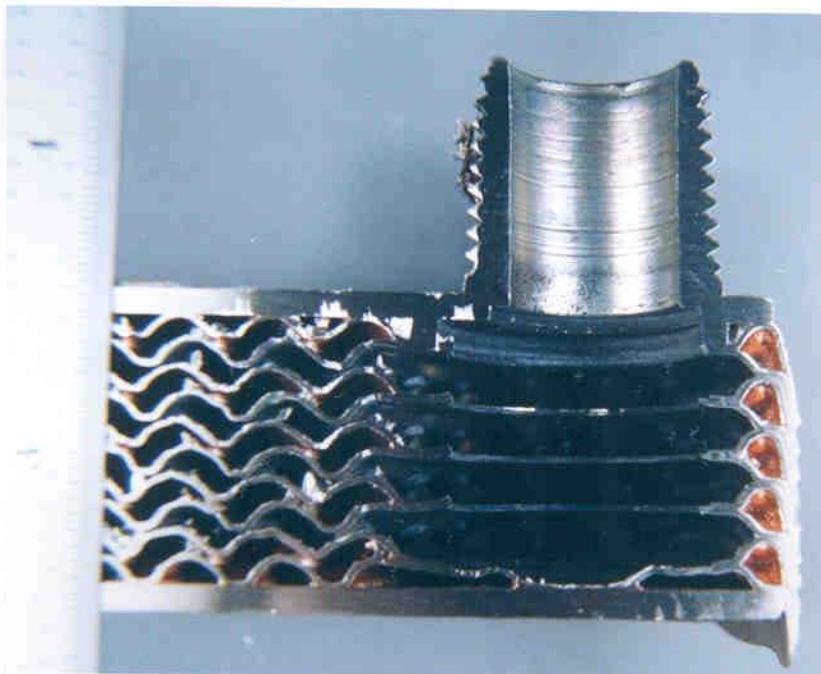
FIG. 8
(12108)

This photograph shows the internal surfaces of the hot geothermal fluid outlet port of the heat exchanger from the OIT system.

These surfaces had conditions similar to the inlet port. The thickest accumulations of the black corrosion deposits were around the fitting-to-plate brazed joints.

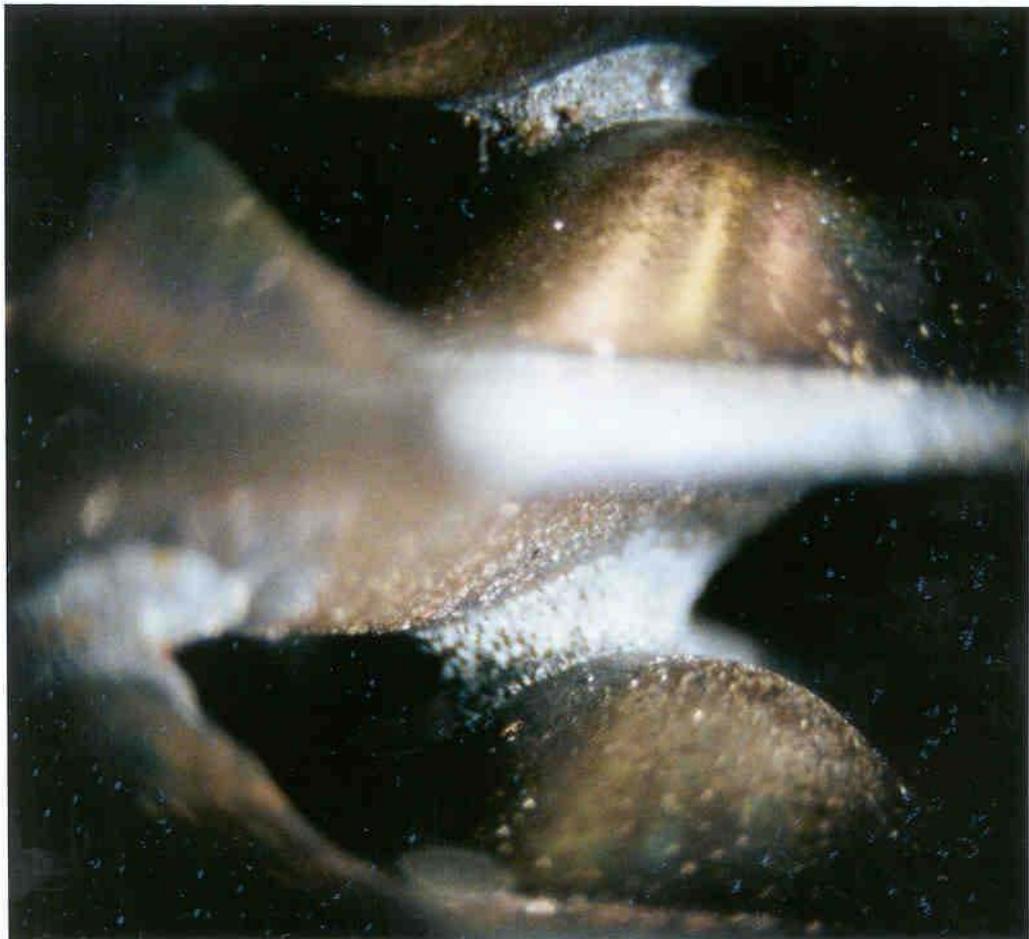
FIG. 9 (12109)

This photograph is a magnified view of a brazed plate joint in the outlet port area. The deposits on the joint were corrosion products from the joint braze metal. The corrosion products were copper and sulfur compounds with moderate amounts of iron, chromium, nickel, silicon and tin.

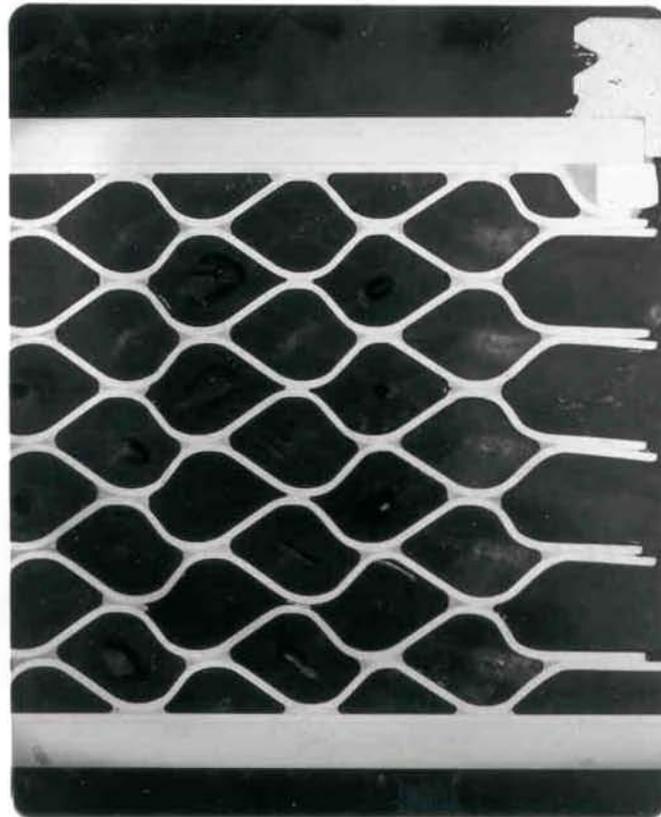
FIG. 10 (10493)

This photomicrograph shows a longitudinal cross section of the outlet port area of the Boise unit. The OIT unit had a similar appearance. The fitting-to-plate joint is on the upper right.

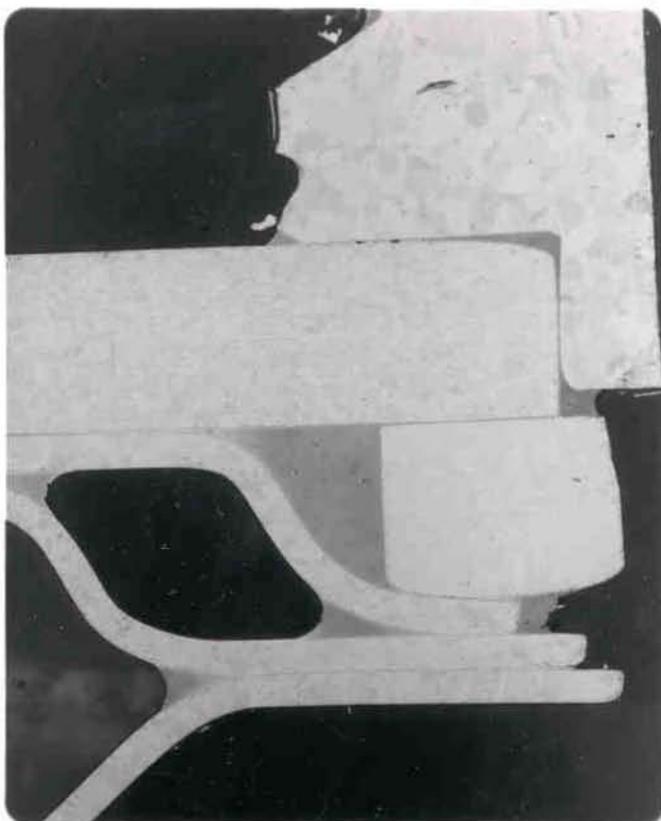
FIG. 11
(10503)

This photomicrograph shows detail of the Boise unit outlet fitting-to-plate joint. The fitting is on top. The thick section below the fitting is the outer plate. The nearly square rectangle is the spacer ring. The three thin sections on the bottom are the first three corrugated heat transfer plates. These members were all made of stainless steel.

The gray material between the steel members is the copper braze material. The braze metal on the right was exposed to the geothermal fluid and has preferentially corroded (arrow) at an approximate corrosion rate of 10 mils per year. Joints like these could leak in 6 to 10 years. The stainless steel surfaces exposed to geothermal water did not show any corrosion.

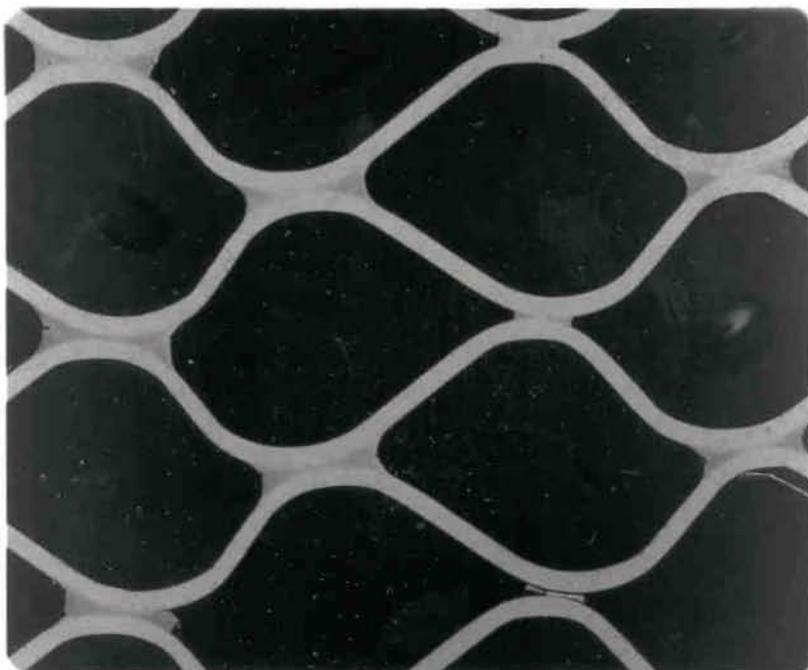
FIG. 12
(10494)

This photomicrograph shows brazed joints between the corrugated, stainless steel heat transfer plates in the heat exchanger core. These joints were located where the plate corrugation peaks crossed the peaks of the adjacent plates. The corrugations crossed at an included angle of approximately 50 degrees. The brazed joints were approximately 0.08 inch wide. The plate braze joints could corrode to failure in 4 years if the braze corrosion continues at the observed rate.

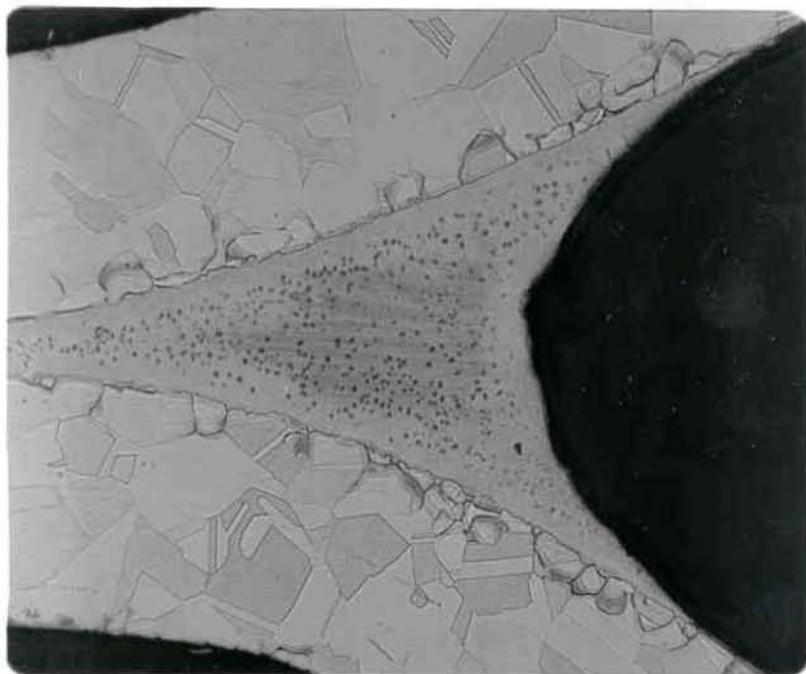
FIG. 13 (10491)

This photomicrograph shows a brazed joint in a secondary/domestic water passage of the Boise unit. This joint had no corrosion deposits. The copper braze filler metal was securely bonded to the stainless steel plates and a smooth, generous fillet formed on the joint surface.

The chemical composition of the plate material was comparable to the specified composition of Type 316 stainless steel. The braze joint material was 96-percent copper with small amounts of manganese, iron, chromium, and nickel.

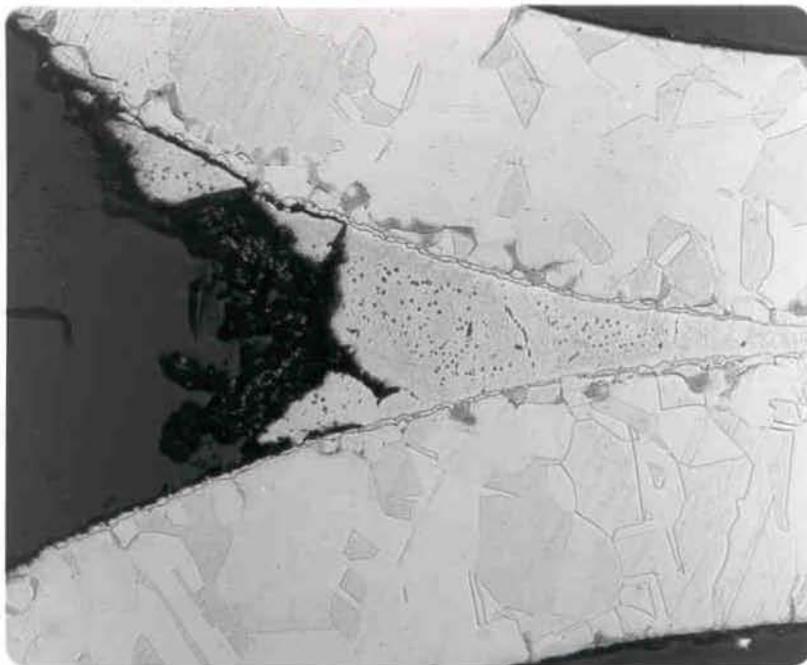
FIG. 14
(10486)

This photomicrograph shows a brazed joint in a primary/geothermal fluid passage in the Boise unit. Corrosion resulting from exposure to the geothermal fluid has attacked the copper braze material to a depth of approximately 0.01 inch.

The copper brazed joints were generally attacked on the surfaces and preferentially attacked along the interfaces between the copper braze joint material and the stainless steel plate material. The stainless steel plate did not corrode.

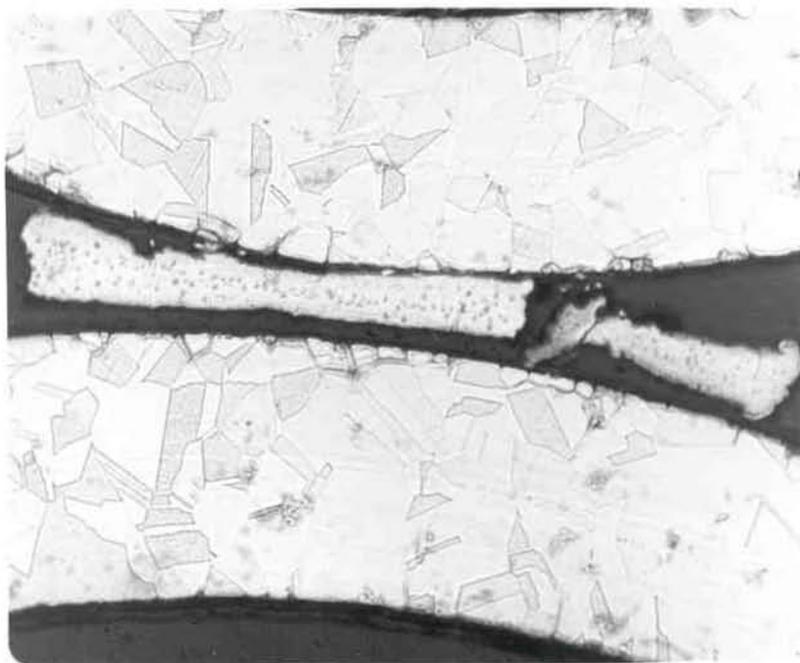
FIG. 15
(10492)

This photomicrograph shows a brazed joint in a primary passage in the Boise unit where the interface corrosion has penetrated entirely through the joint. Only one instance of this condition was observed in the sample, but it serves to illustrate the eventual outcome of continued corrosion of the copper brazed joints.

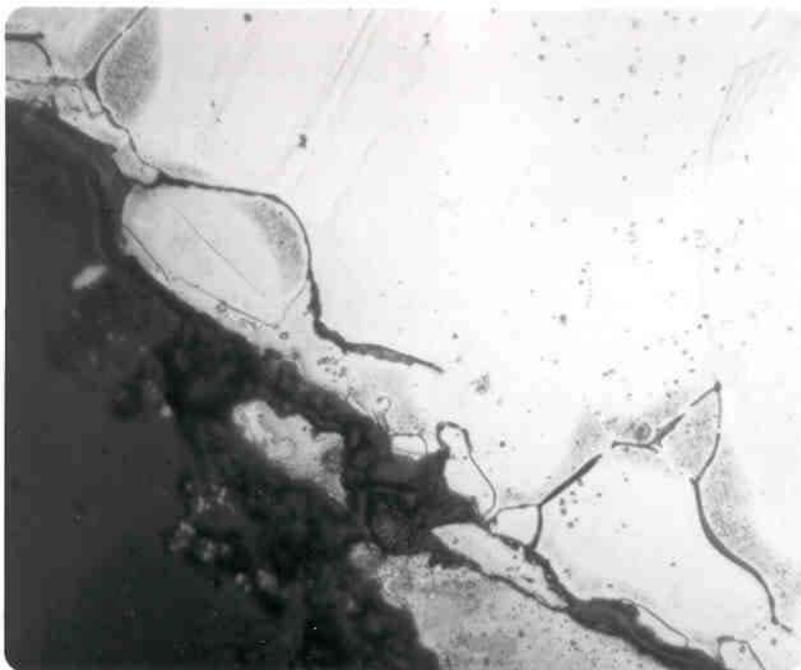
FIG. 16
(10488)

This photomicrograph shows detail of the preferential corrosive attack along the joint-to-plate interface. The presence of copper in the stainless steel grain boundaries has allowed the corrosion to attack the plates, leaving open, unbonded grain boundaries in the plate surfaces. These may, at a later time, be sites of intergranular corrosion and/or crack initiation, but do not show active corrosion at this time.

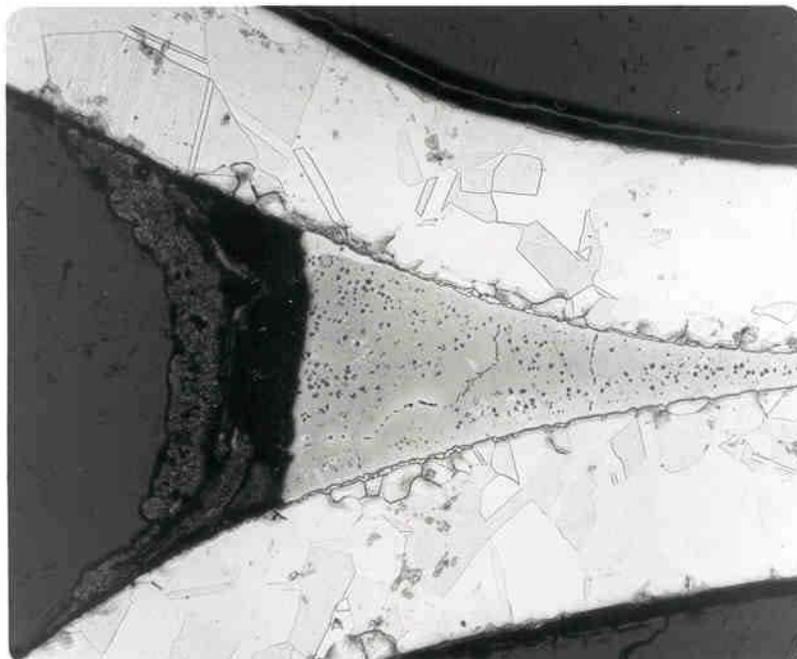
FIG. 17
(10500)

This photomicrograph shows a brazed joint in a primary/geothermal fluid passage in the OIT unit. Corrosion resulting from exposure to the geothermal fluid has attacked the copper braze material to a depth of approximately 0.01 inch.

The copper brazed joints were generally attacked on the surfaces but not preferentially attacked along the interfaces.

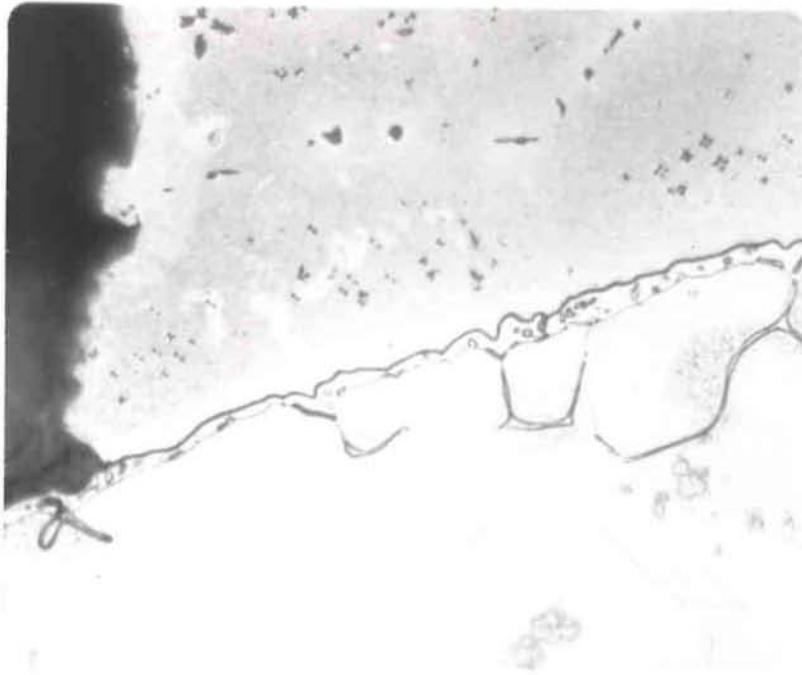
FIG. 18
(10501)

This scanning electron micrograph shows a stainless steel grain boundary near the joint-to-plate interface where copper has penetrated from the brazing operation.

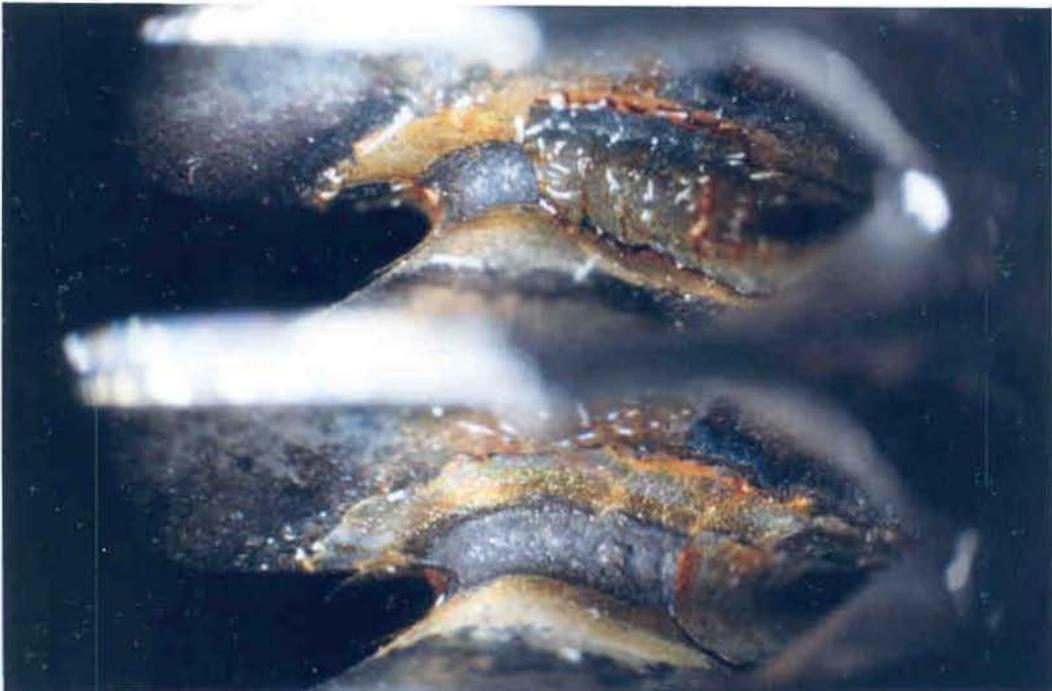
FIG. 4
(14181)

This photograph is a magnified view of two brazed joints in the inlet port area showing the corrosion scale and areas of the braze where the scale had broken off. The corrosion scale was primarily copper and sulfur, with less amounts of iron, arsenic, nickel, aluminum, manganese, and calcium.

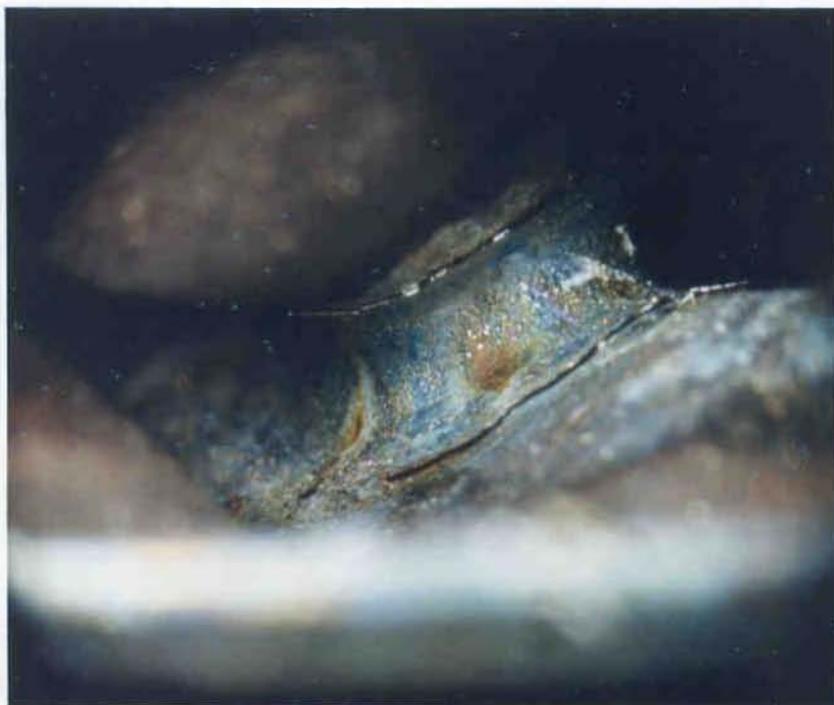
FIG. 5
(14182)

This photograph is a magnified view of a brazed joint in the hot outlet port area. The corrosion scale in the joint was intact, but had started to peel from the plates and braze metal, and will eventually break off.

The cracks along the edge are between the scale and stainless steel.

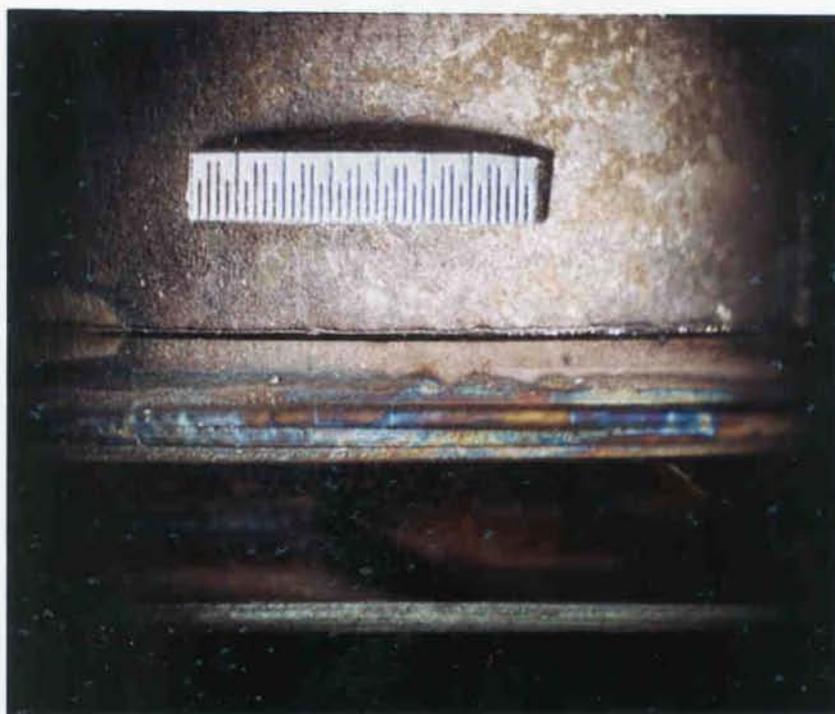
FIG. 6
(14183)

This photograph shows a gap between the outlet port fitting and top plate. This joint was not completely filled by braze metal. Its depth and extent of corrosion are shown in Figures 8 and 14.

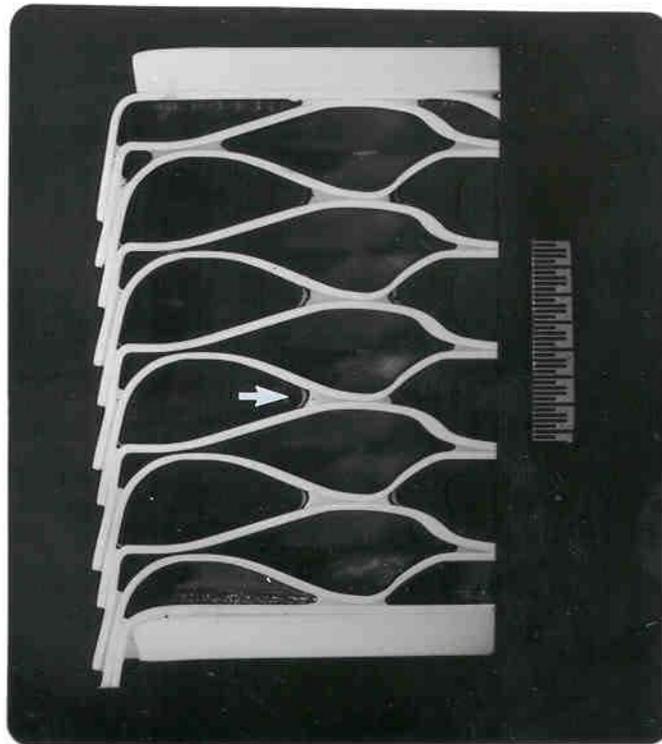
FIG. 7
(13542)

This photomicrograph shows a transverse cross section in the area of the hot outlet port. A layer of corrosion scale is visible on both sides of the inner plate-to-plate copper brazed joints.

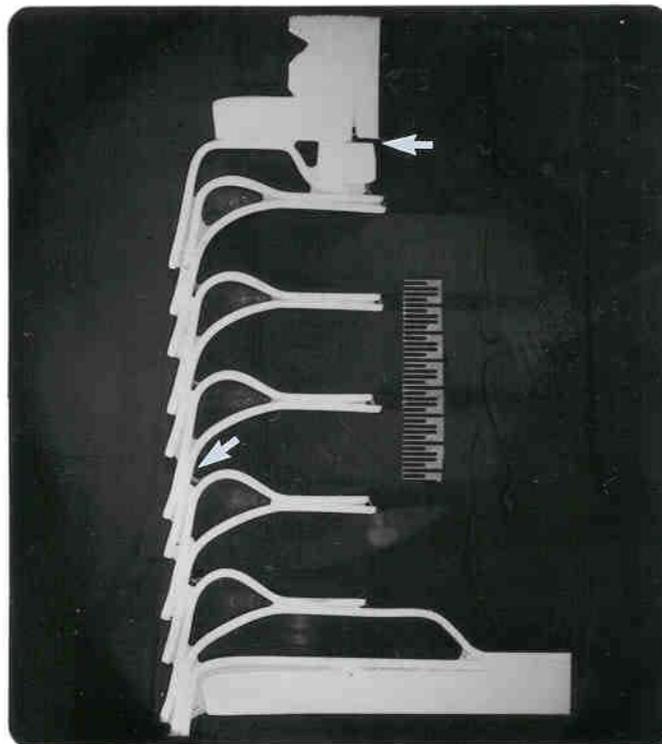
FIG. 8
(13541)

A gap between the fitting and top plate is shown by the top arrow.

Corrosion of the side wall plate-to-plate braze is visible (bottom arrow). Both features are examined in Figures 11 and 12.

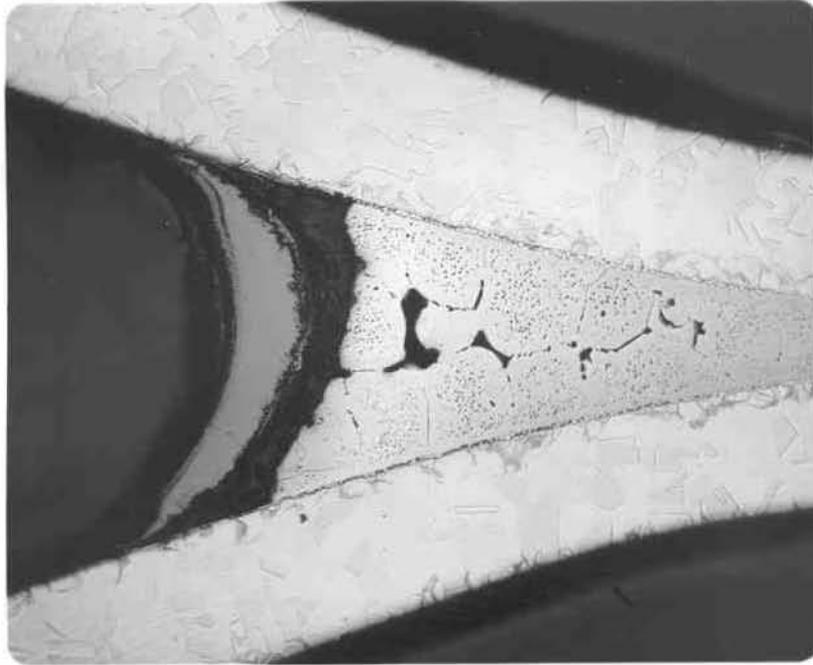
FIG. 9
(13535)

This photomicrograph shows detail of the brazed joint shown by the arrow in Figure 7. This joint is in a geothermal fluid passage, and corrosion from contact with this fluid has attacked the copper braze metal to a depth of approximately 0.014 inch.

The corrosion products consisted primarily of copper and sulfur, and the corrosion rate was approximately 0.33 inch per year. At this rate, such joints could fail in as little as 3 years.

These joints, like those of the Boise unit, were attacked primarily on the braze metal surfaces exposed to geothermal fluid, but some preferential attack along the copper-to-stainless steel interface was also present.

The stainless steel showed no evidence of corrosion, but some copper in grain boundaries uncovered by corrosion of the braze metal has been attacked, leaving open grain boundaries in the plate surfaces. These may be future sites for intergranular corrosion and/or crack initiation.

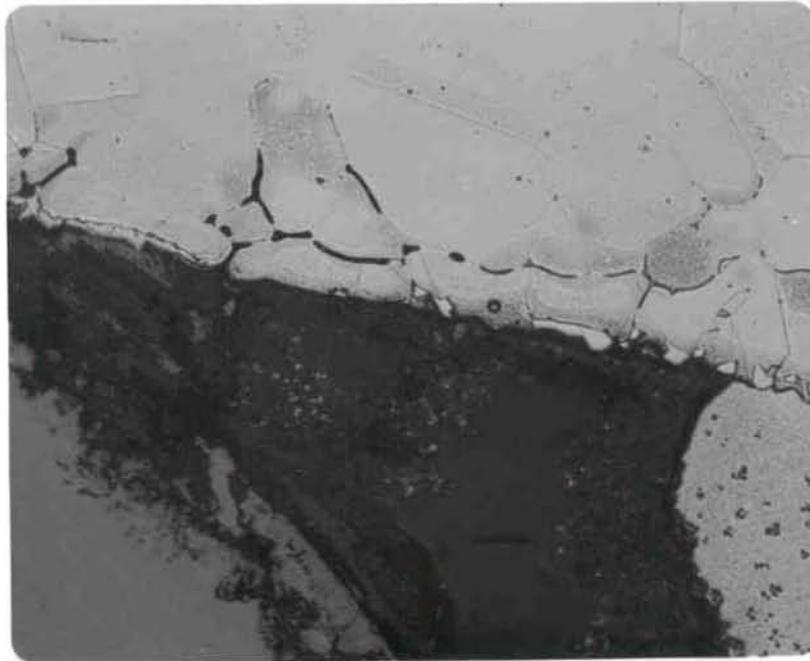
FIG. 10
(13536)

This photomicrograph is a magnified view of the preferential attack of the copper braze metal along the copper-to-stainless steel interface. Open grain boundaries in the plate surface due to attack of intergranular copper are visible. No active corrosion of the stainless steel has occurred.

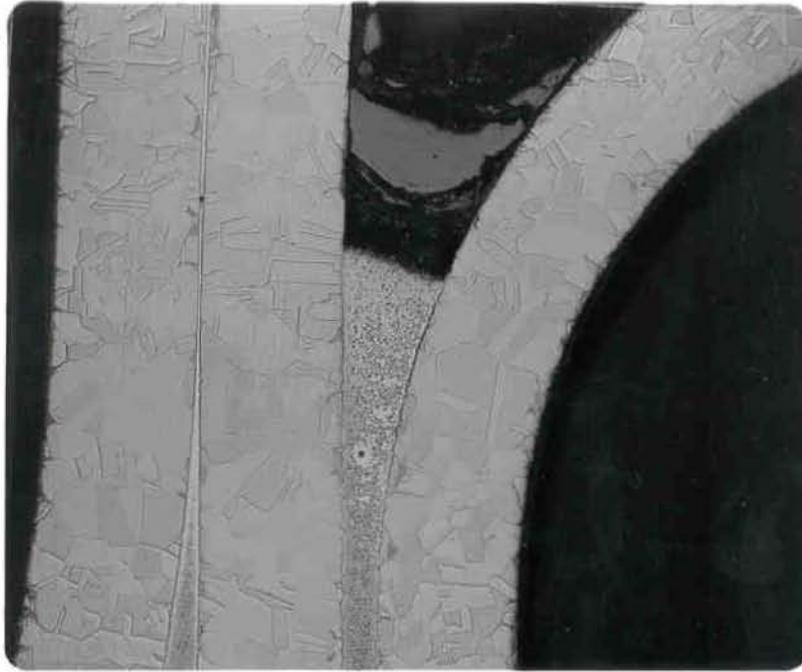
FIG. 11
(13540)

Corrosion has attacked the copper braze metal to a depth of approximately 0.02 inch. Because this attack is on only one side of the joint, failure would take much longer than failure of internal geothermal passage joints and would not be the limiting factor in unit life.

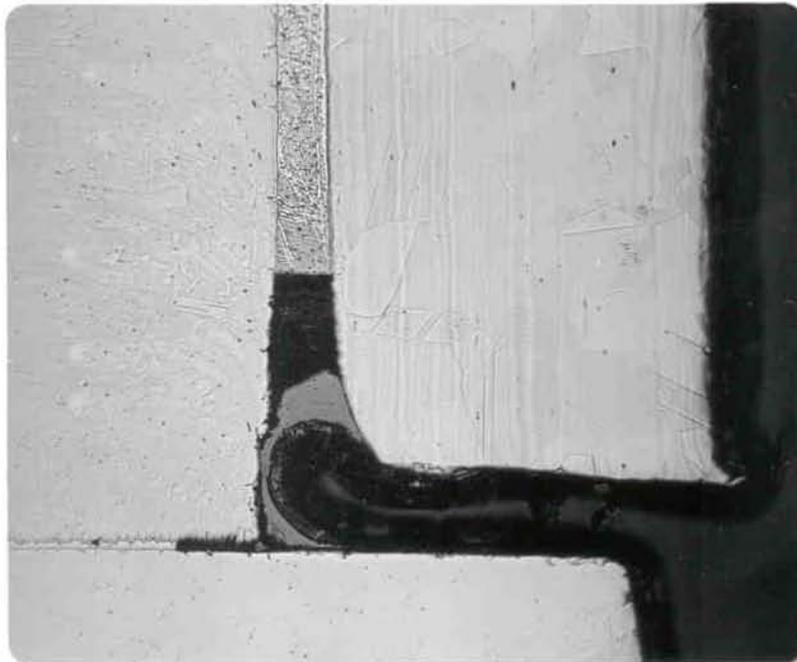
FIG. 12
(13539)

Though some corrosion was present, the primary cause of the gap appears to be mechanical mismatch. Again, with attack occurring only on one side of the braze, this joint would not be the limiting factor in the unit's life.
