SUNDOWN M RANCH YAKIMA, WASHINGTON

Dr. R. Gordon Bloomquist, Ph.D.,
Washington State University Energy Program

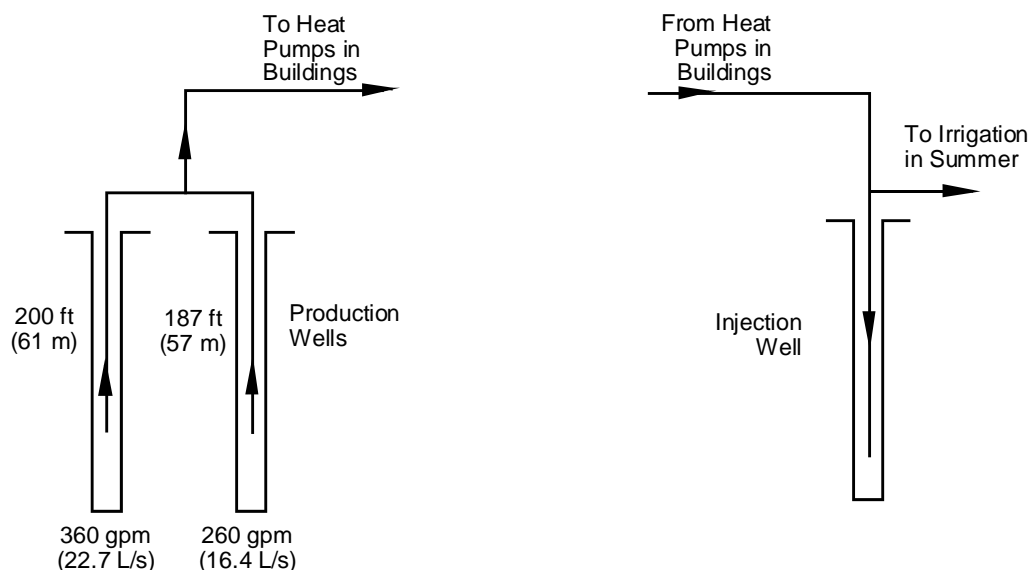
Figure 1. Process schematic of Sundown M Ranch.

A process schematic is shown in Figure 1.

The complex is served by two production wells at ca 57°F (13.9°C) and one injection well. The main well is approximately 200 ft (61 m) deep, and provides 360 gpm (22.7 L/s) via a 15-hp (11 kW) submersible pump. The

second well is 187 ft (57 m) deep and supplies 260 gpm (16.4 L/s). It has a 15-hp (11 kW) submersible pump. After passing through the heat pump, the water is injected or used for irrigation during the summer months. The well pumps are run 24-hours per day at constant speed. Flow is controlled through the use of throttling valves. There are also two domestic water wells on the property. In addition to use for heating and cooling and domestic purposes, the wells together can supply a maximum of 1,100 gpm (69.4 L/s) for fire protection.

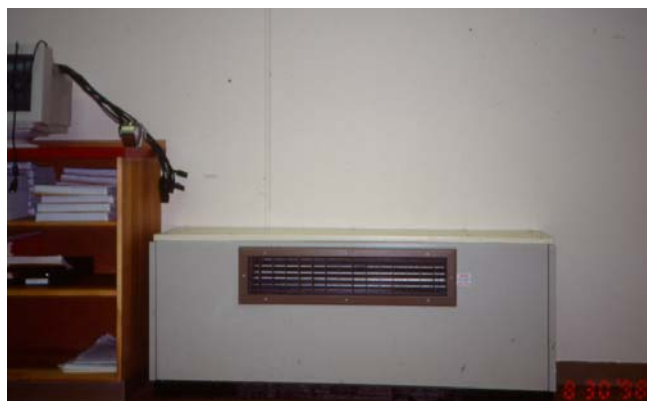
Figure 2. Console heat pump.

The various facilities are served by a combination of heat pumps and heat pump unit ventilators (Figure 2). Water is circulated in an open loop to each building. Circulating pumps serve to boost the flow through the various buildings. A total of 297 heat pumps supply the complex comprised of 257 1-ton (3.5 kW) heat pump unit ventilators, 12 3-ton (10.5 kW) units, and 28 5-ton (17.6 kW) units for a total of 433 tons (1,523 kW). In addition, there are four 5-ton (17.6 kW) water-to-water heat pumps in the adult building for hot water and two 5-ton (17.6 kW) units with back-up electric water heaters serving the youth facility (Figure 3). There is a 1,000 gallon (3785 L) hot water storage tank in the adult facility.

Each heat pump has a valve that opens or closes depending on whether the heat pump is on. The heat pumps and unit ventilation have outdoor air access and are controlled by thermostats.

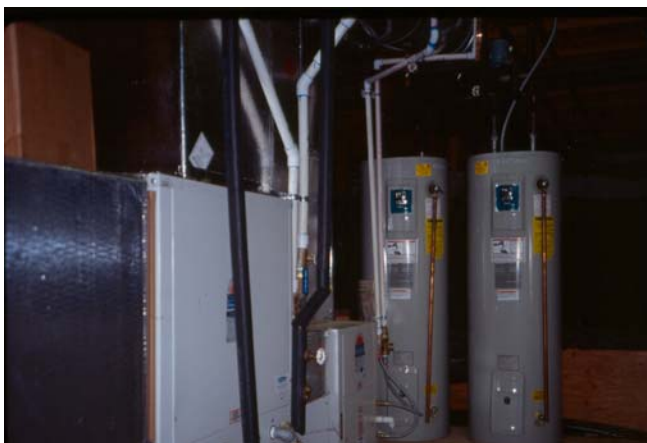
Figure 3. Water to water heat pump.
