A BRIEF HISTORY OF DHE MATERIALS

Gene Culver
Geo-Heat Center

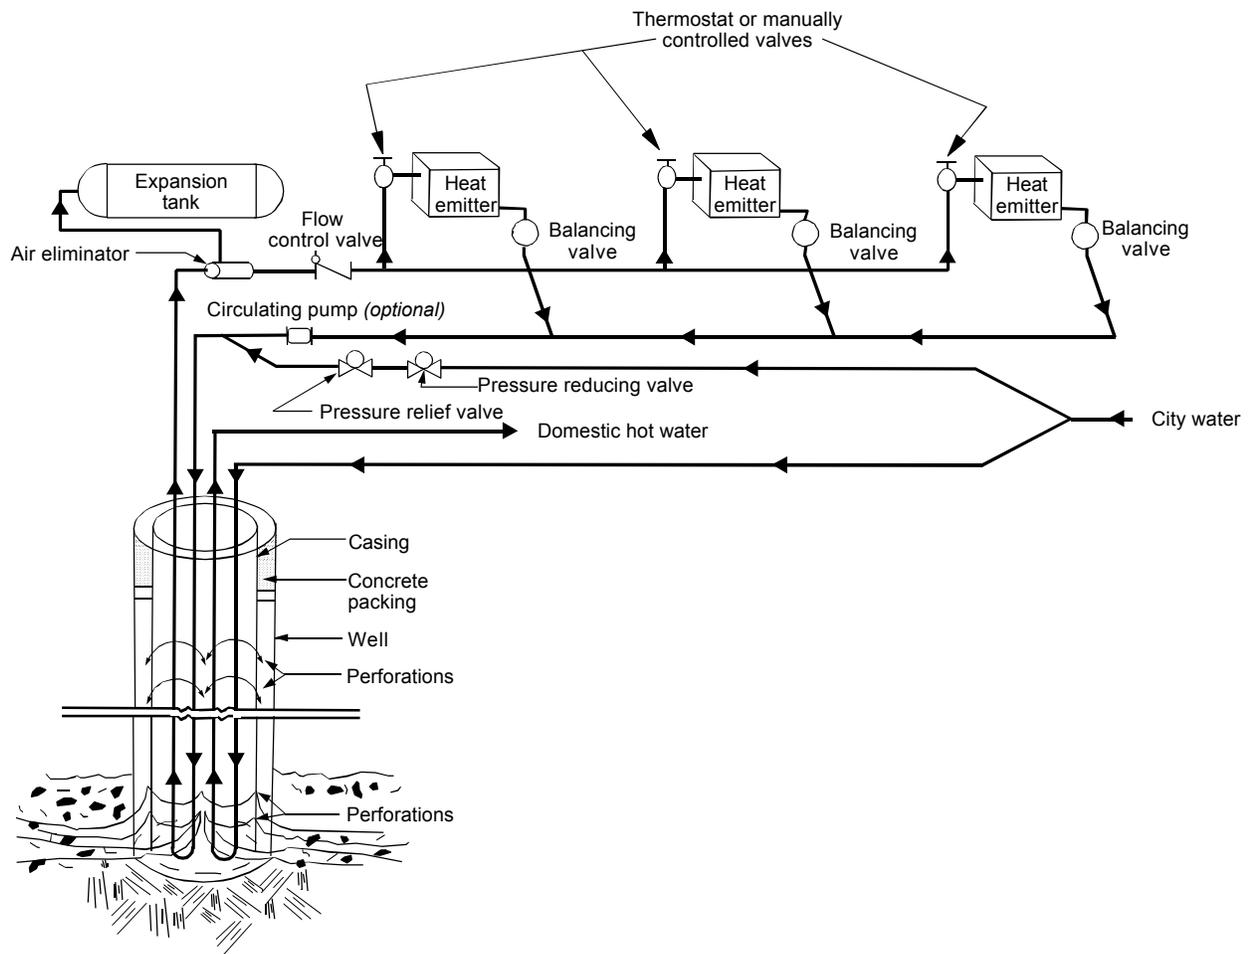
Figure 1. Typical downhole heat exchanger system (Klamath Falls, OR).

Before long DHEs were being installed in other wells and their success in reducing problems in the aboveground parts of the system led to increased drilling of the resource (Figure 1). In non-artesian wells, corrosion near the water level was the major problem; although, failures do occur at other locations (Figures 2 and 3). Non-artesian DHE life was generally on the order 10 - 15 years—in artesian wells, about twice as long.

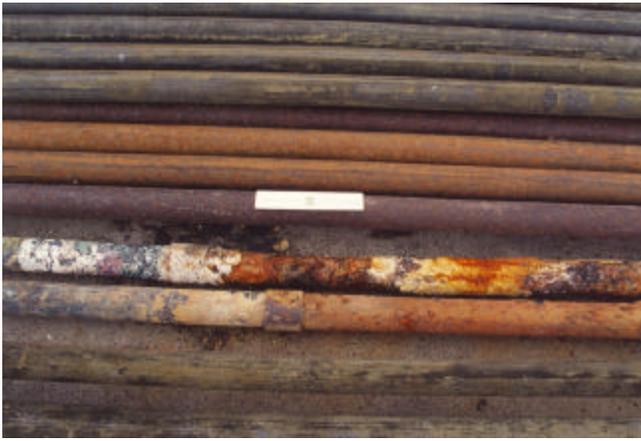
Figure 2. *Corrosion and failure of a residential DHE at the air/water interface.*

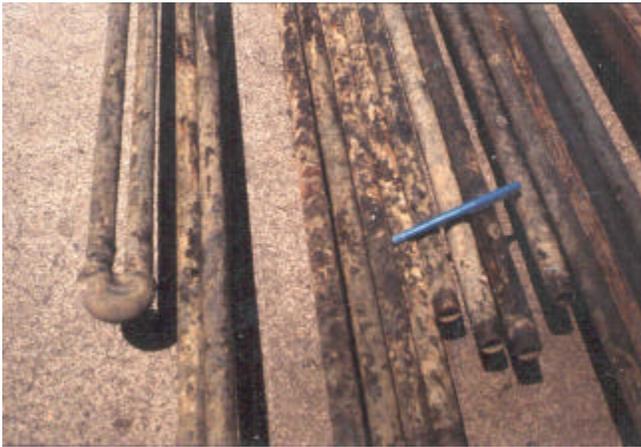
Figure 3. *Corrosion and pitting of DHE replaced in 1974. Note the Reverse loop at the bottom of the heat exchanger.*

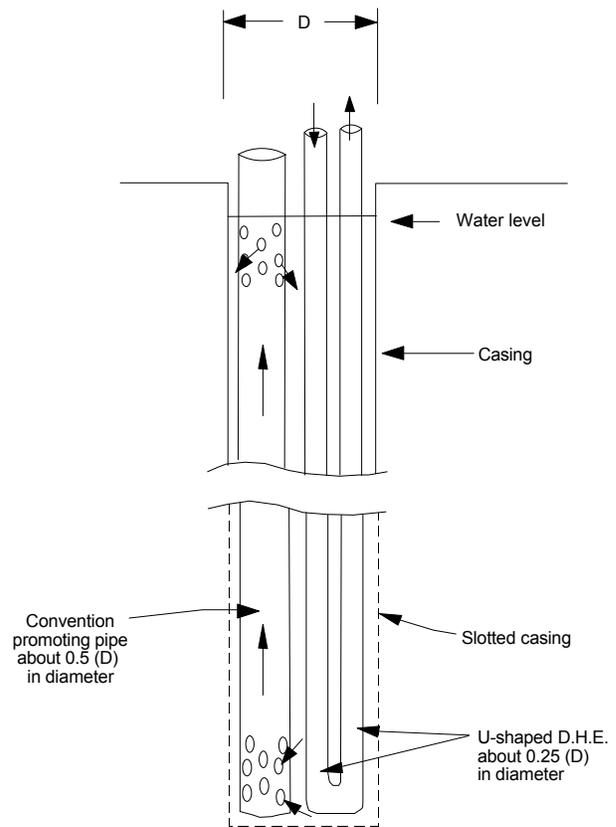
Figure 4. Convection promoter and DHE (New Zealand type).

Well boreholes will not stand open in the softer formations; so, the convection flow outside the casing is not possible. Wells are equipped with a convection promoter (Figure 4) with the DHE either inside or outside the promoter—but the corrosion problems are the same—at the water level. As far as is known, black iron pipe is the only material used for the DHEs—the rigorous exclusion of air by sealing the top.
