# CONTINUING ADVANCES IN PEX DOWNHOLE EXCHANGERS FOR DIRECT-USE HEATING APPLICATIONS

*Andrew Chiasson, Geo-Heat Center, Oregon Institute of Technology*

Installation and monitoring of the first known cross-linked polyethylene (PEX) downhole heat exchanger (DHE) was described in previous work by Chiasson, et al., (2005). This article describes the second-known PEX DHE installation for direct-use heating applications.

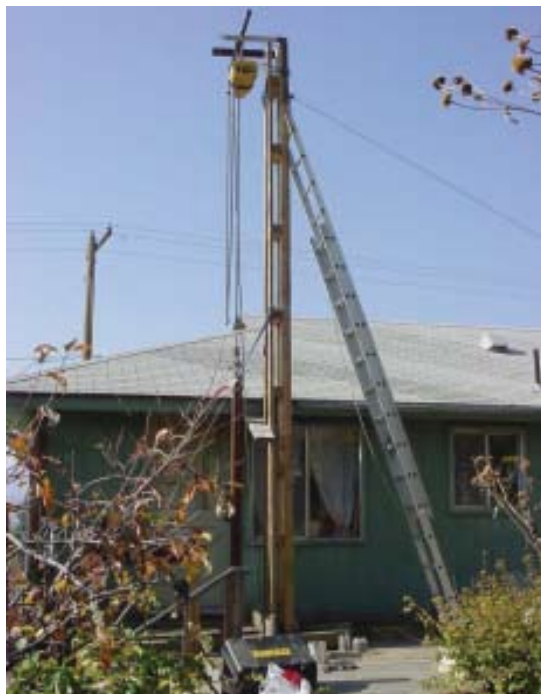
*Figure 1. Photograph of removal of old black iron DHE.*

As mentioned above, the only way to remove the black iron DHE was with a manually-operated winch. A photograph of the DHE removal process is shown in Figure 1. Figure 2 is a photograph from the basement location of the well, showing heavy scale and corrosion of the black-iron DHE as it is being pulled from the well. Not visible in the photograph are several pinholes that were observed in the black iron pipe, which were the cause of the water leaks.

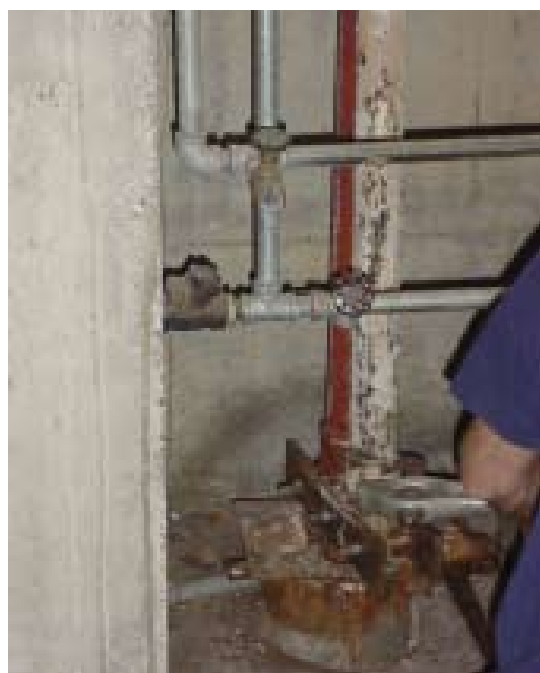
*Figure 2. Photograph of removal of old black iron DHE, showing heavy scale deposits and corrosion.*

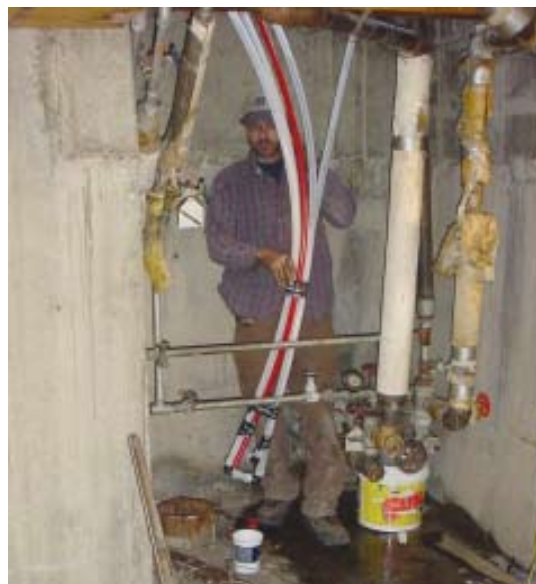
Two PEX loops of 1-inch nominal diameter pipe were installed. In addition, a single  $\frac{3}{4}$ -inch red PEX tube was also installed with the DHE to act as an access tube for well temperature monitoring and also to act as a convection promoter. To promote convection of hot water within the well, the  $\frac{3}{4}$ -inch PEX tube was perforated at its lower end and at the level of the water table.

*Figure 3. Photograph of double u-tube PEX DHE assembly prior to insertion into the well with dark (red) promoter pipe.*

A photograph of the entire PEX DHE assembly prior to insertion into the well is shown in Figure 3. The final installation is shown in Figure 4. The entire installation process of the PEX DHE into the well was completed easily in less than an hour with three people.

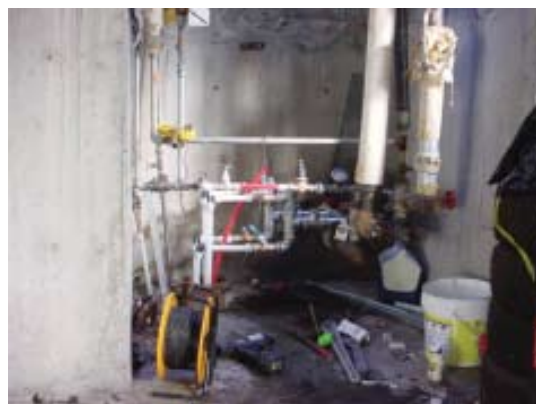
*Figure 4. Photograph of the completed double u-tube PEX DHE.*
