**RESULTS OF INVESTIGATIONS OF
FAILURES OF GEOTHERMAL
DIRECT-USE WELL PUMPS**

**U.S. Department of Energy
Contract No.: DE-FG07-90ID 13049 A007**

Gene Culver

**Geo-Heat Center
Oregon Institute of Technology
Klamath Falls, OR**

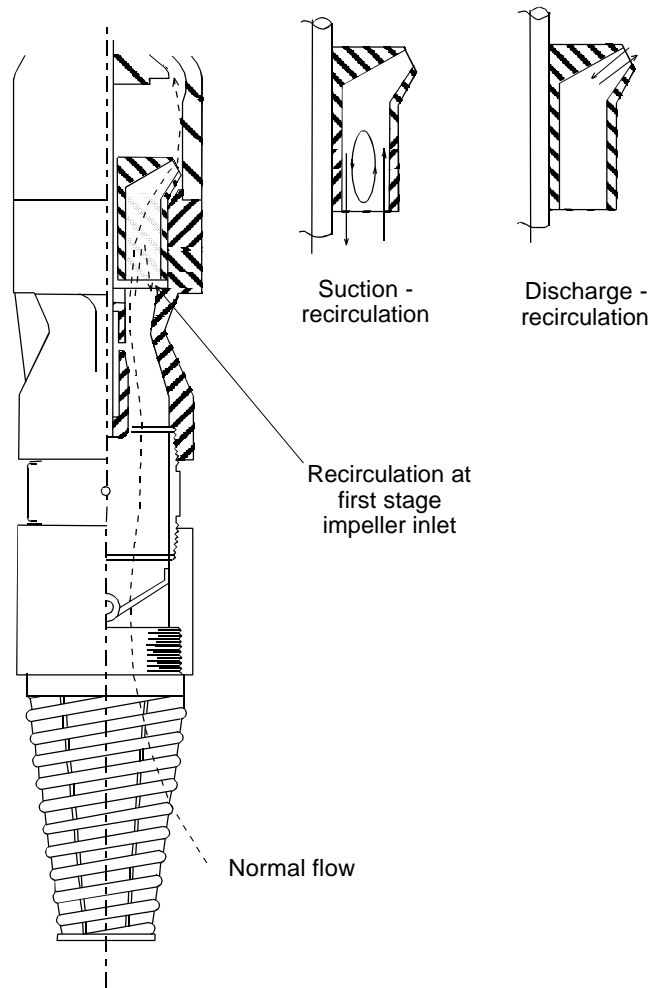
Internal recirculation (Figure 16) is a phenomenon occurring in all centrifugal pumps at certain reduced flows. This results in flow reversals in both the suction and discharge areas of the impeller. The result of these reversals is the formation of vortices creating low pressure and the formation of vapor bubbles in these areas. The subsequent collapse of these bubbles results in greatly increased vibration and pressure pulsations, and erosion of impeller vanes similar to cavitation caused by insufficient net positive suction head (NPSH), but on the hidden high-pressure side of the vanes instead of the low-pressure side.

Figure 16. Suction and discharge recirculation.
