# KLAMATH COUNTY VANDENBERG ROAD COMPLEX

Gene Culver  
Geo-Heat Center

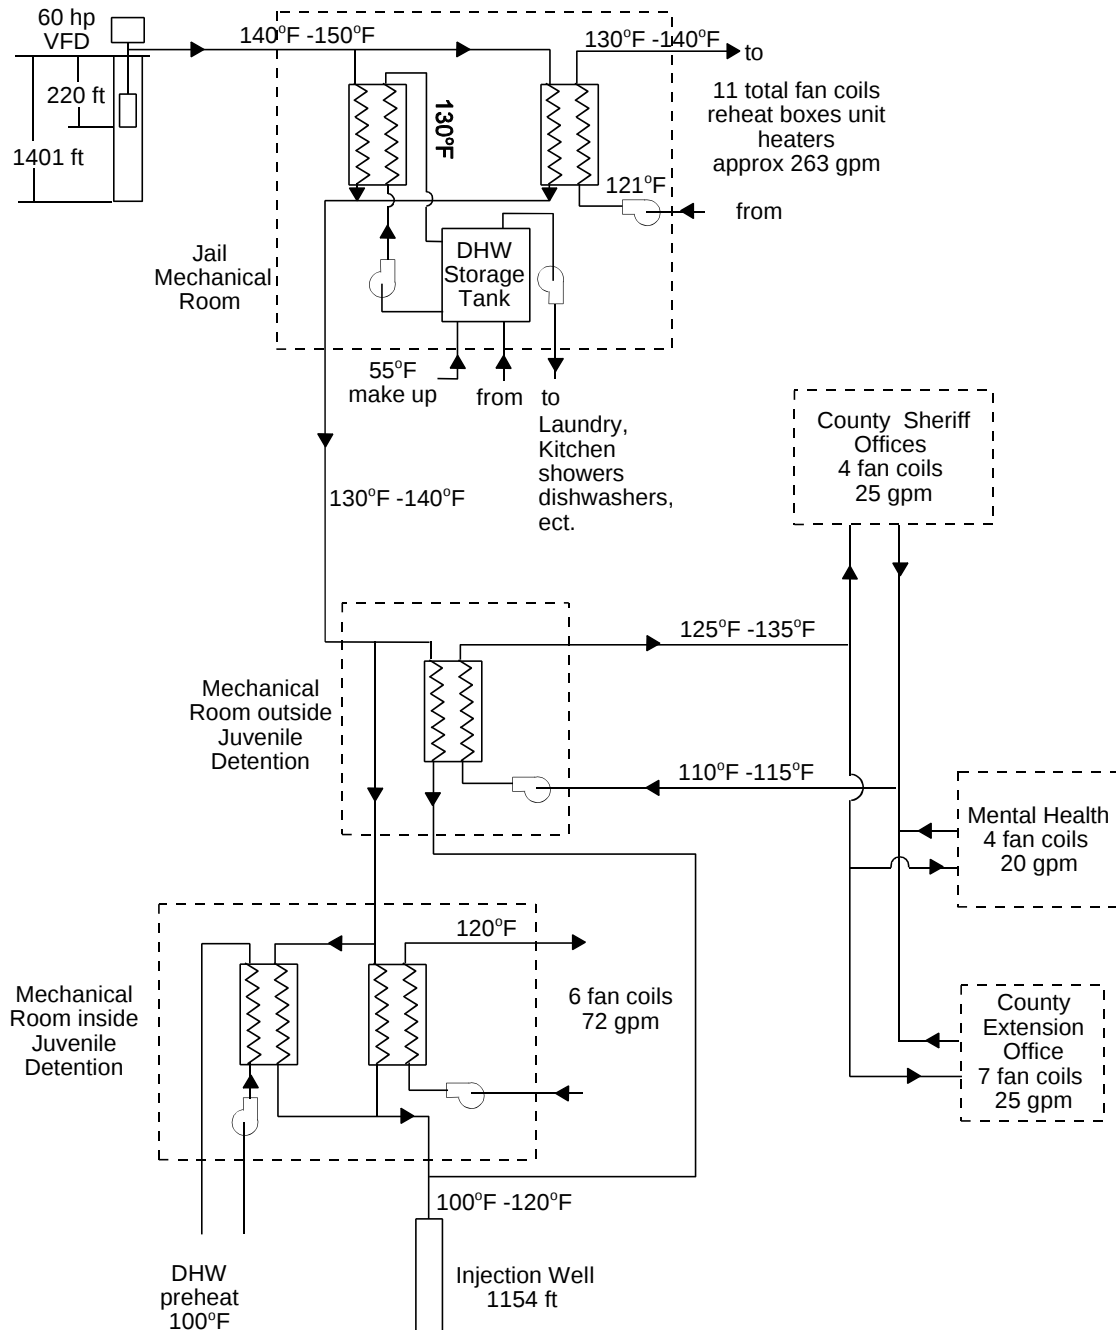
The County Jail, 42,600 sq ft, was completed in 1990. The production well serving the Juvenile Home, County Health, Mental Health and Extension Offices converted to an injection well and the entire complex supplied from the new well. The system schematic is shown. Flows shown are peak design from drawings and are probably never that high. The jail has six fan coils, reheat boxes and unit heaters supplied from a main stainless steel plate heat exchanger. A separate heat exchanger supplies hot water for showers, kitchen, laundry, etc.
